# EXPLOSION AT WALTON COLLIERY YORKSHIRE

On the causes of, and circumstances  
attending, the explosion which occurred at  
Walton Colliery, Yorkshire,  
on 22nd April, 1959

**T. A. ROGERS, C.B.E.**

**H.M. Chief Inspector of Mines and Quarries**

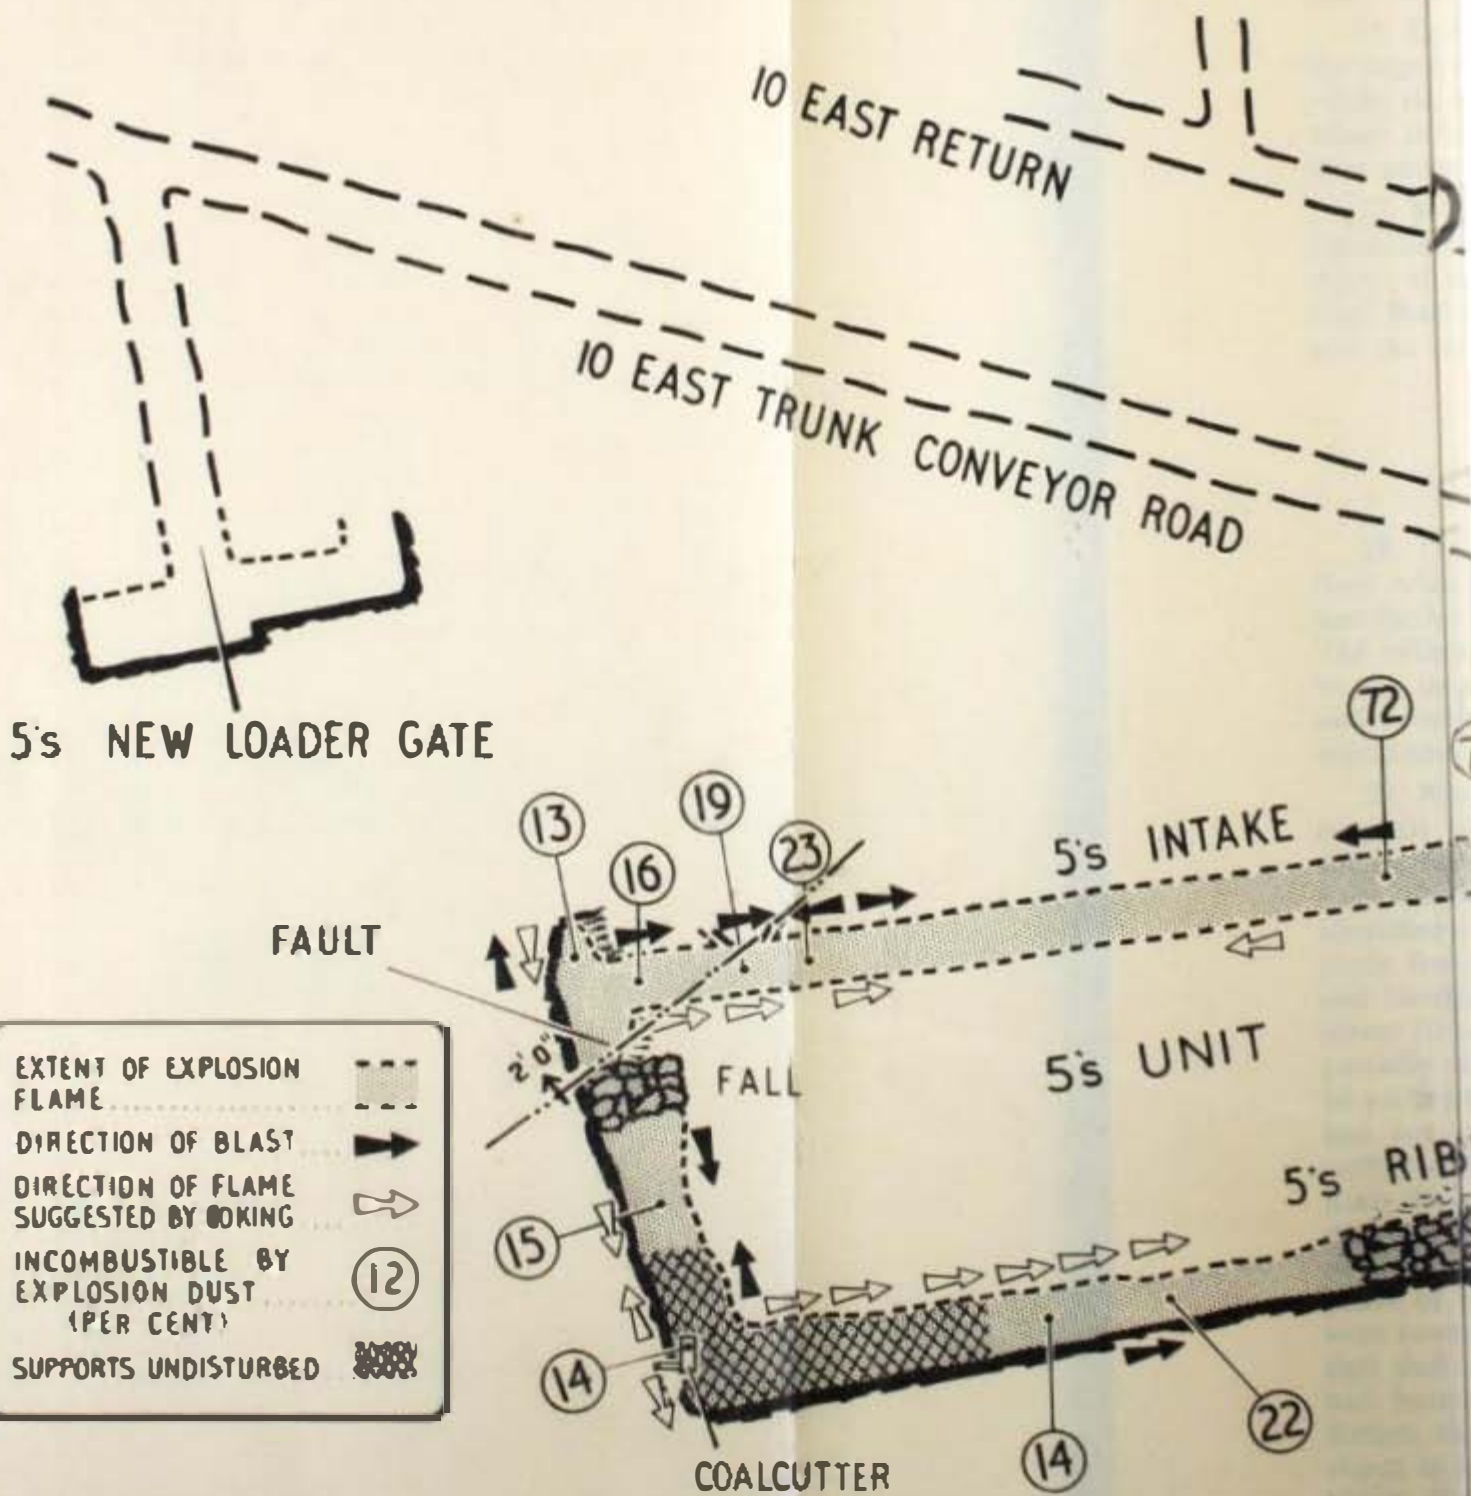
FIGURE 1

Plan showing development of the explosion

46. My conclusion is that this explosion was one based on the joint contribution of gas and coal dust. It began when an electric arc from a damaged trailing cable ignited firedamp near the left corner of 5's Face.

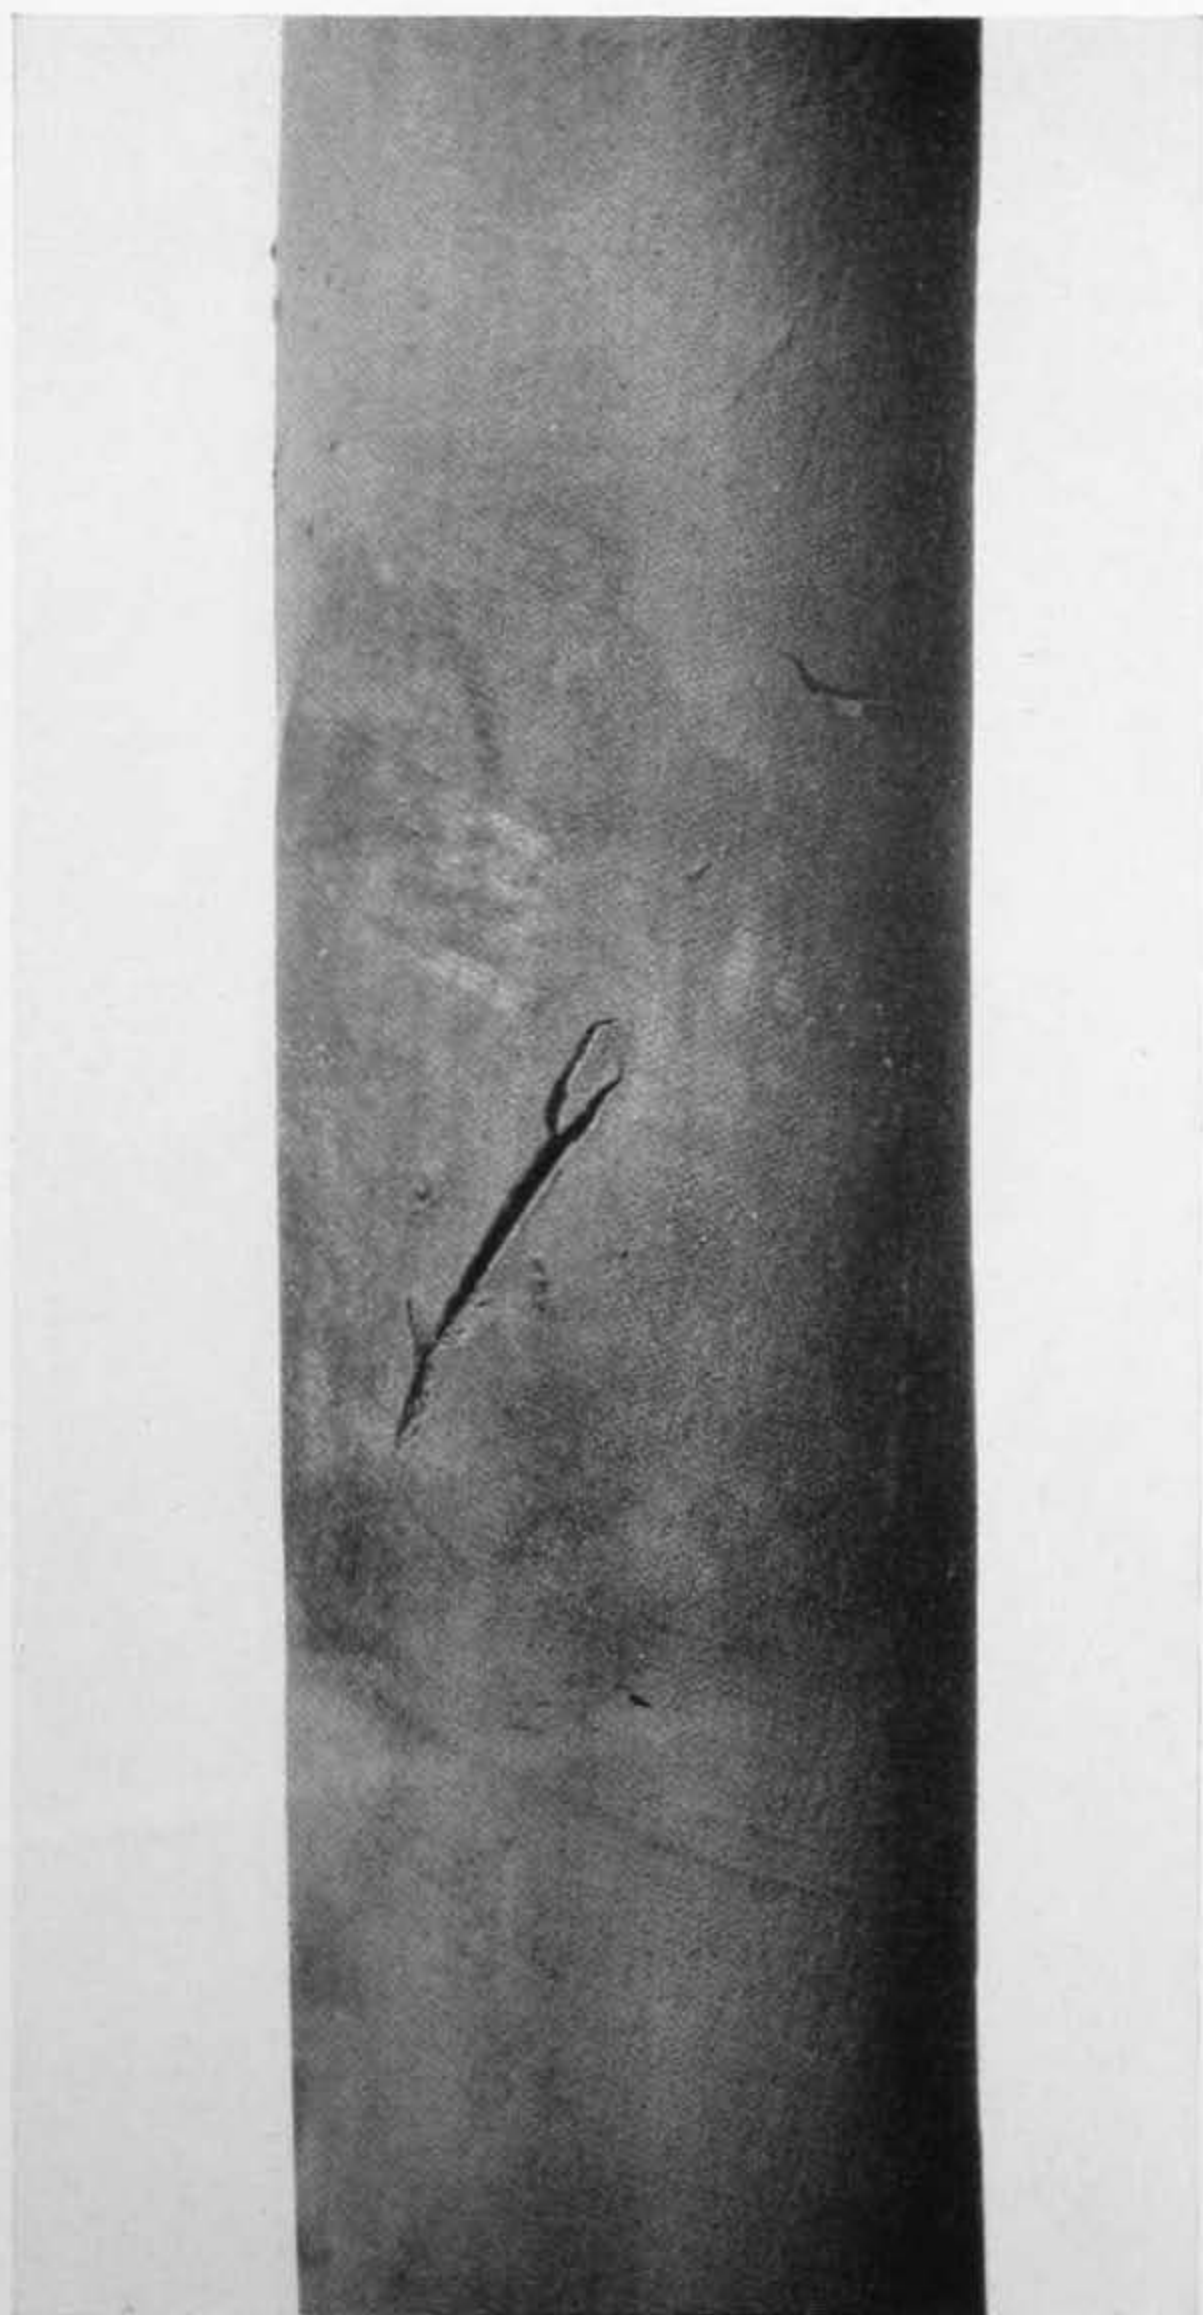
36. The trailing cable was that which supplied the coal cutting machine. When the outer sheath of that cable was examined closely it was seen to contain a superficial cut at about 11 feet, and a deep cut about an inch long at about 21 feet, from the machine end. The damaged cable was carefully dissected. Beneath the cut, and between the outer sheath and the screened conductors, there was a patch of white powder. This was later shown to be similar in composition to the rock of the roof. There had been severe arcing between a power conductor and its earthed screen; the wires of both showed signs of fusion and there were indications of heating on the inside of the cut in the sheath. Plates I-IV show the cable before, and at various stages during, dissection.

The first two of these hypotheses are, in my view, improbable. Though the coal cutter haulage rope contained broken wires, there were no signs of fusion on the protruding ends. Moreover, a micro-chemical analysis of material from the fused conductor, together with a metallurgical examination of the picks in use on 5's Unit, showed that there were no unusual traces either of iron in the fused copper conductor or of copper on the steel pick points. These circumstances are not conclusive since the initial damage was not necessarily caused while the cable was alive. A stronger objection is that neither hypothesis accounts for the presence of a quantity of rock dust inside the cable.

40. On the whole, I think that the last hypothesis was the most probable one, though it is impossible to say how or when the damage occurred. Intervals of a few hours to a day before the explosion were suggested, but the period may conceivably have been longer. A contact made between the conductor and its screen while the cable was "dead" could have been

PLATE I.—View of damaged cable, showing cut in outer sheath.

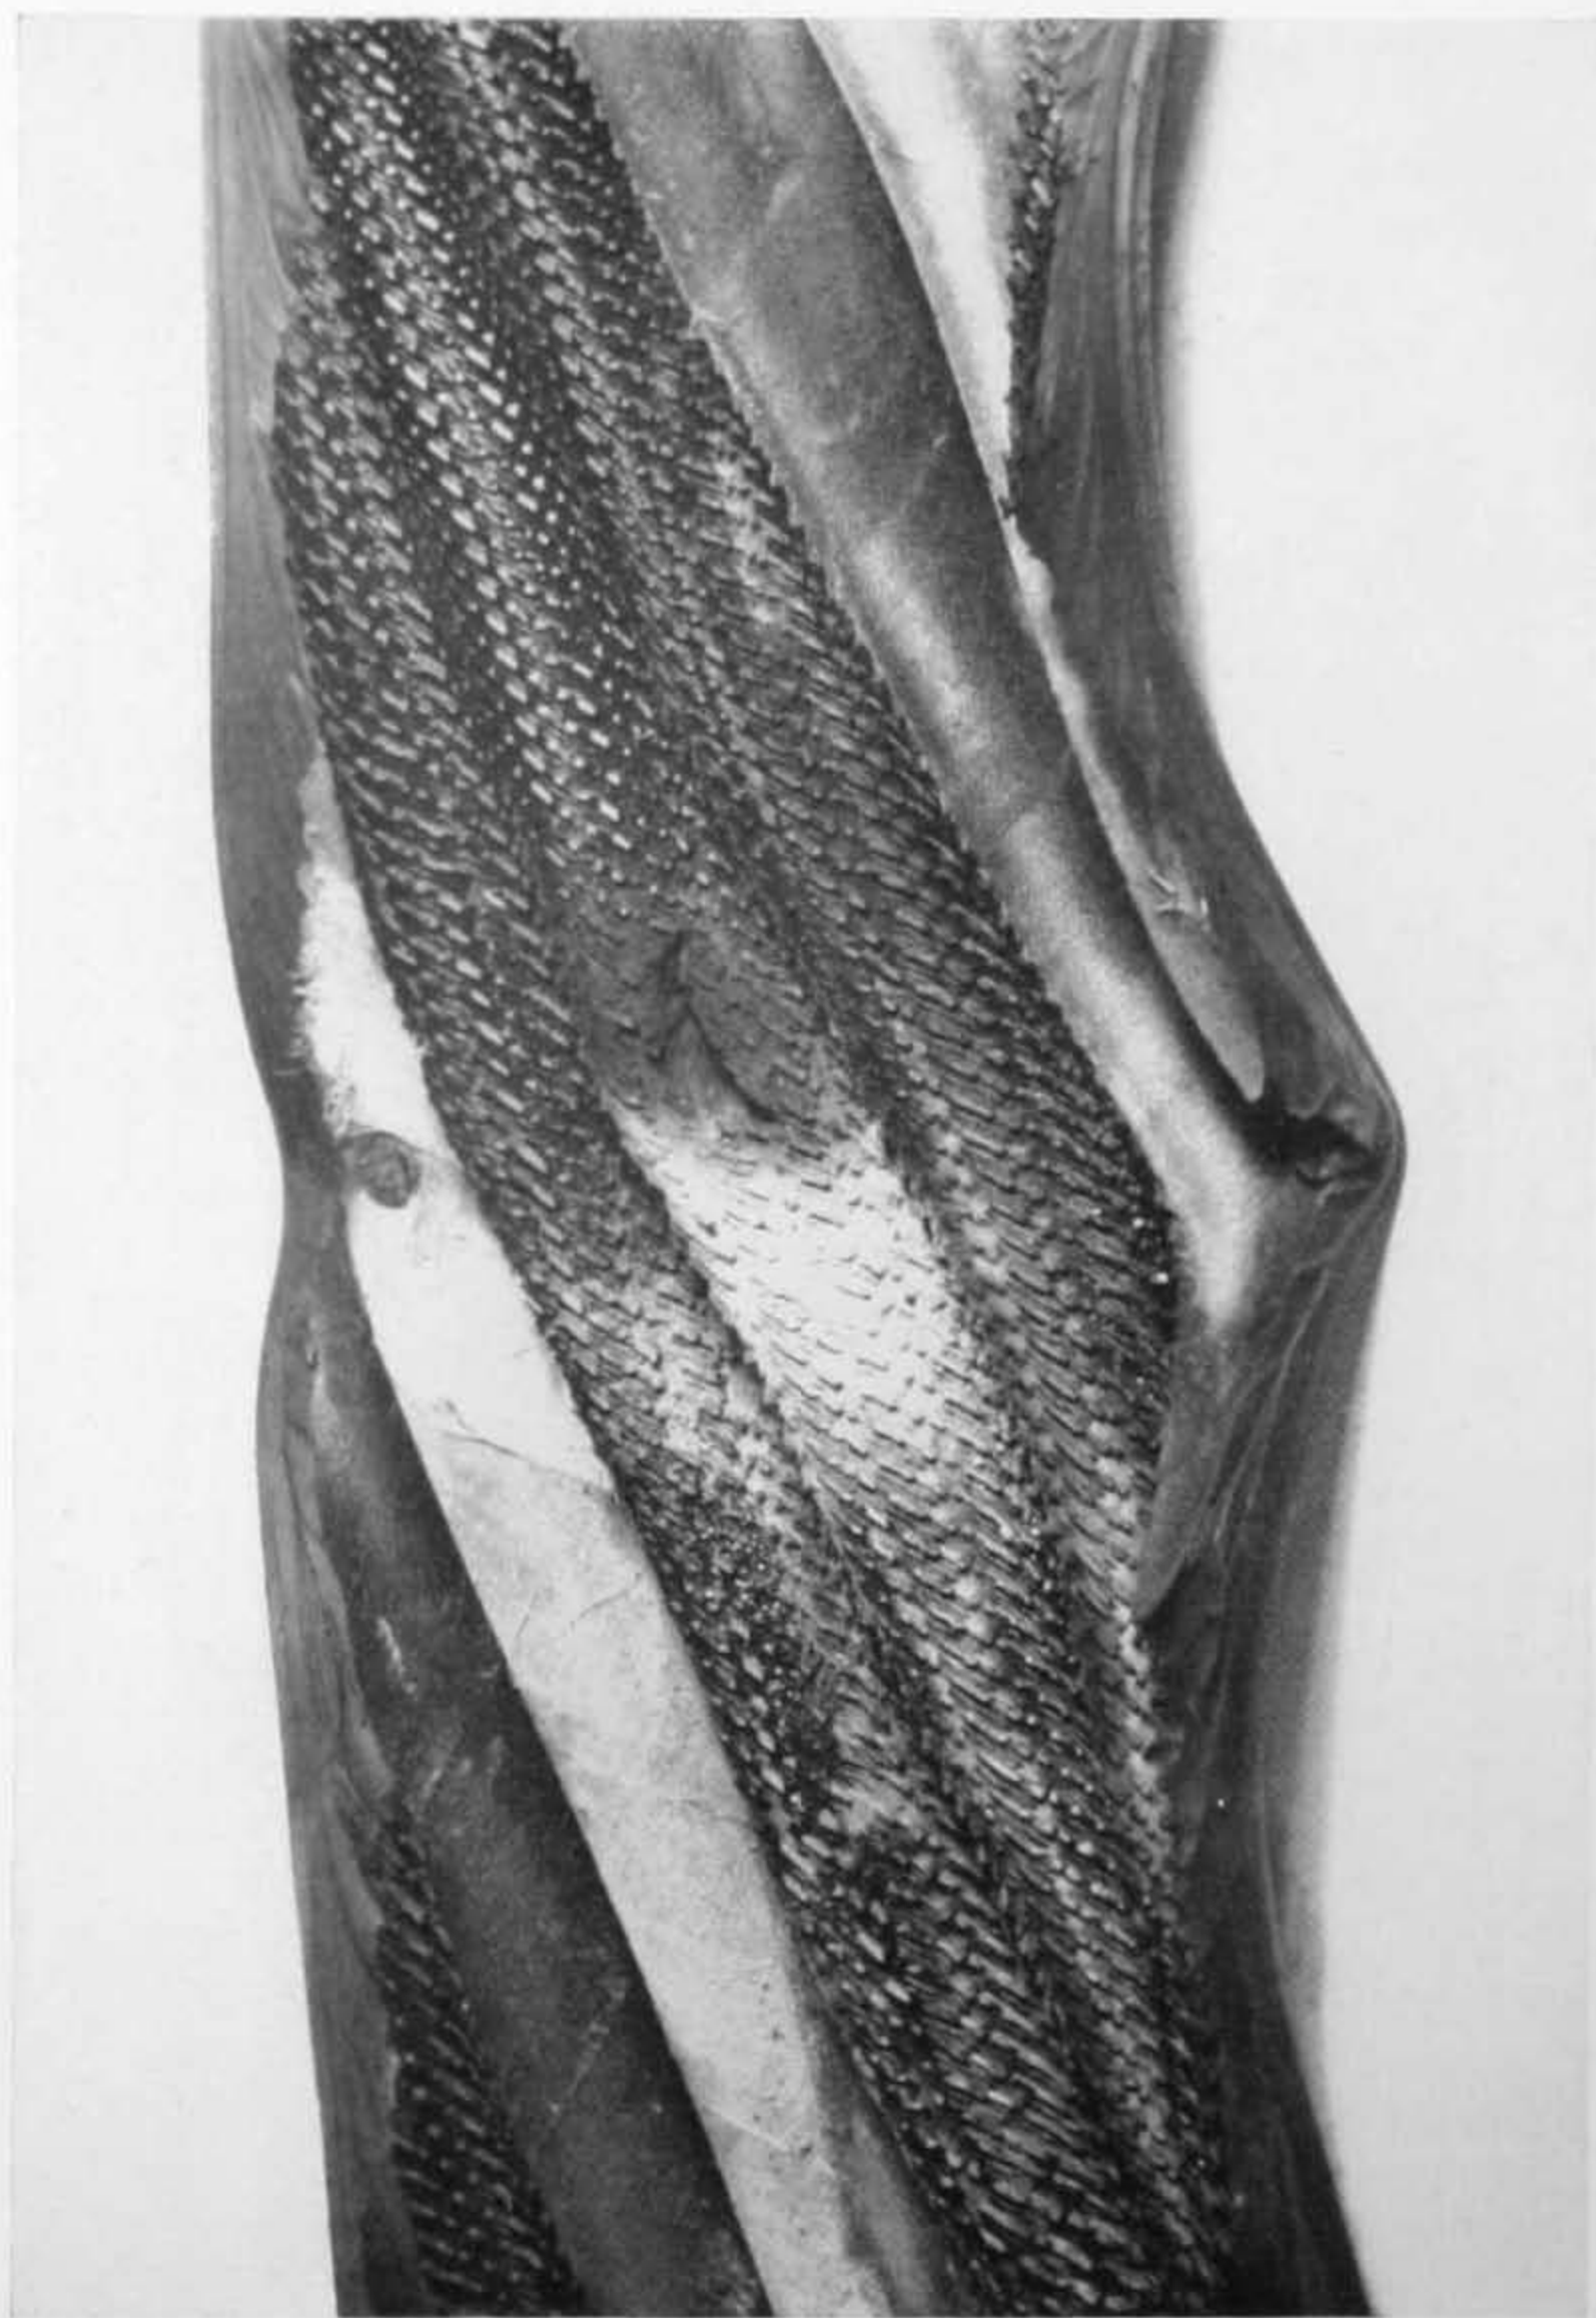
PLATE II.—View of interior surface of damaged sheath showing the cut and white dust.

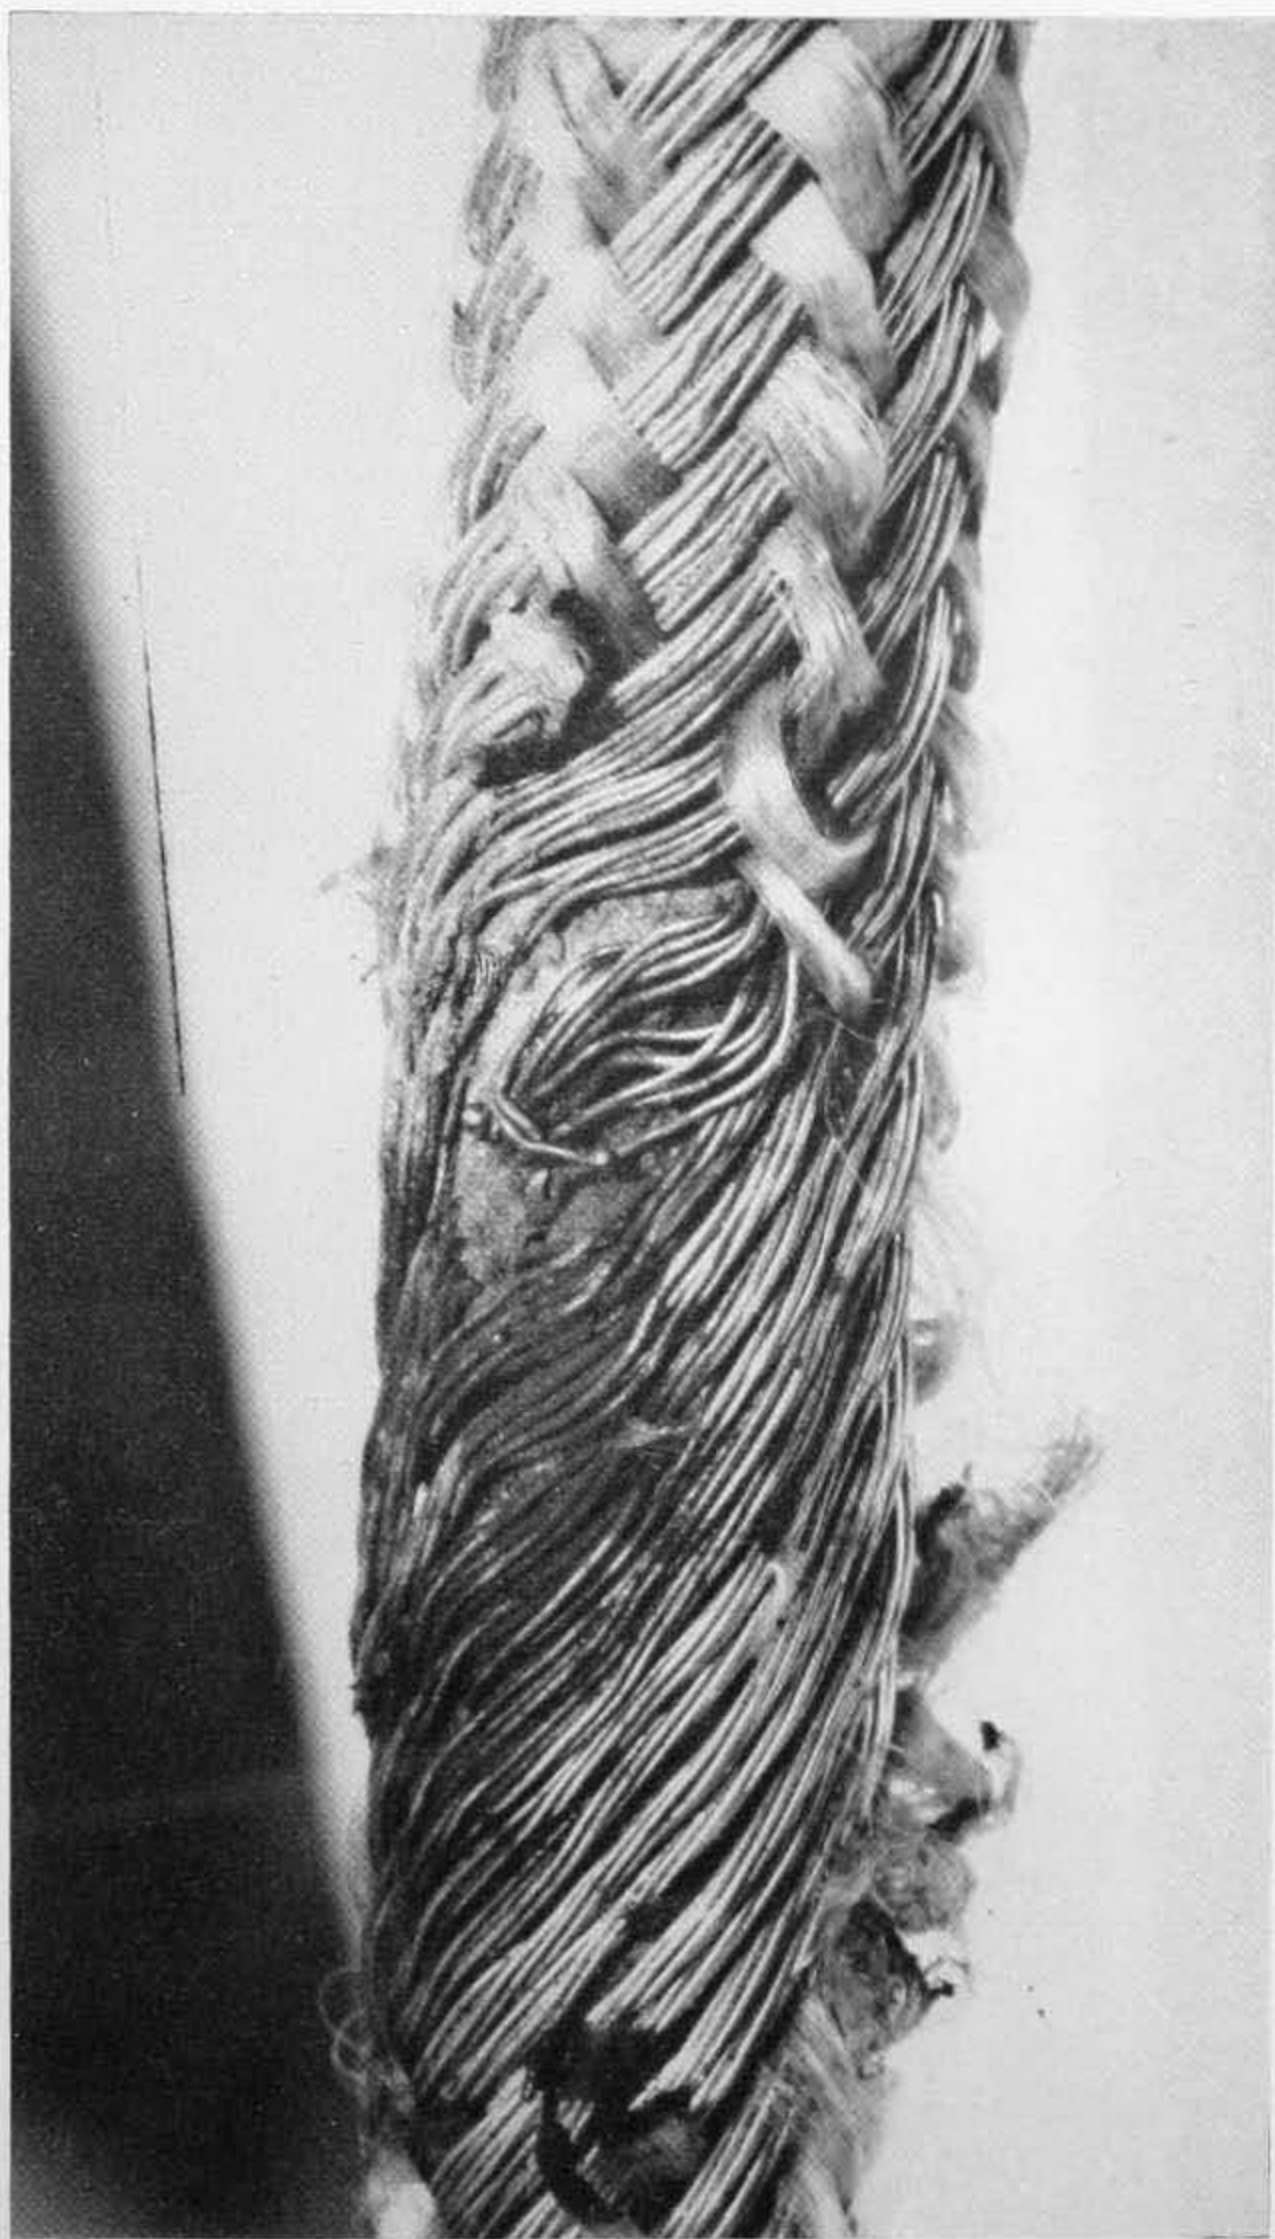
PLATE III.—View of damaged screen of power conductor (conductor removed from cable).

80. The trailing cable was of the type known as "type 14 of British Standard 708", widely used in British mines, in which each power conductor has a protective earthed screen. Earthed screens and associated earth-leakage protection devices—in this case the core balance type—offer protection against the risk of electric shock, but not necessarily against the ignition of firedamp by an arc should an electrical fault develop as the result, for example, of physical damage to the cable.

82. Further study is certainly required, and I recommend that discussions should begin as soon as possible between electrical engineers of the Ministry of Power and of the National Coal Board with a view to a further attack on the problem.

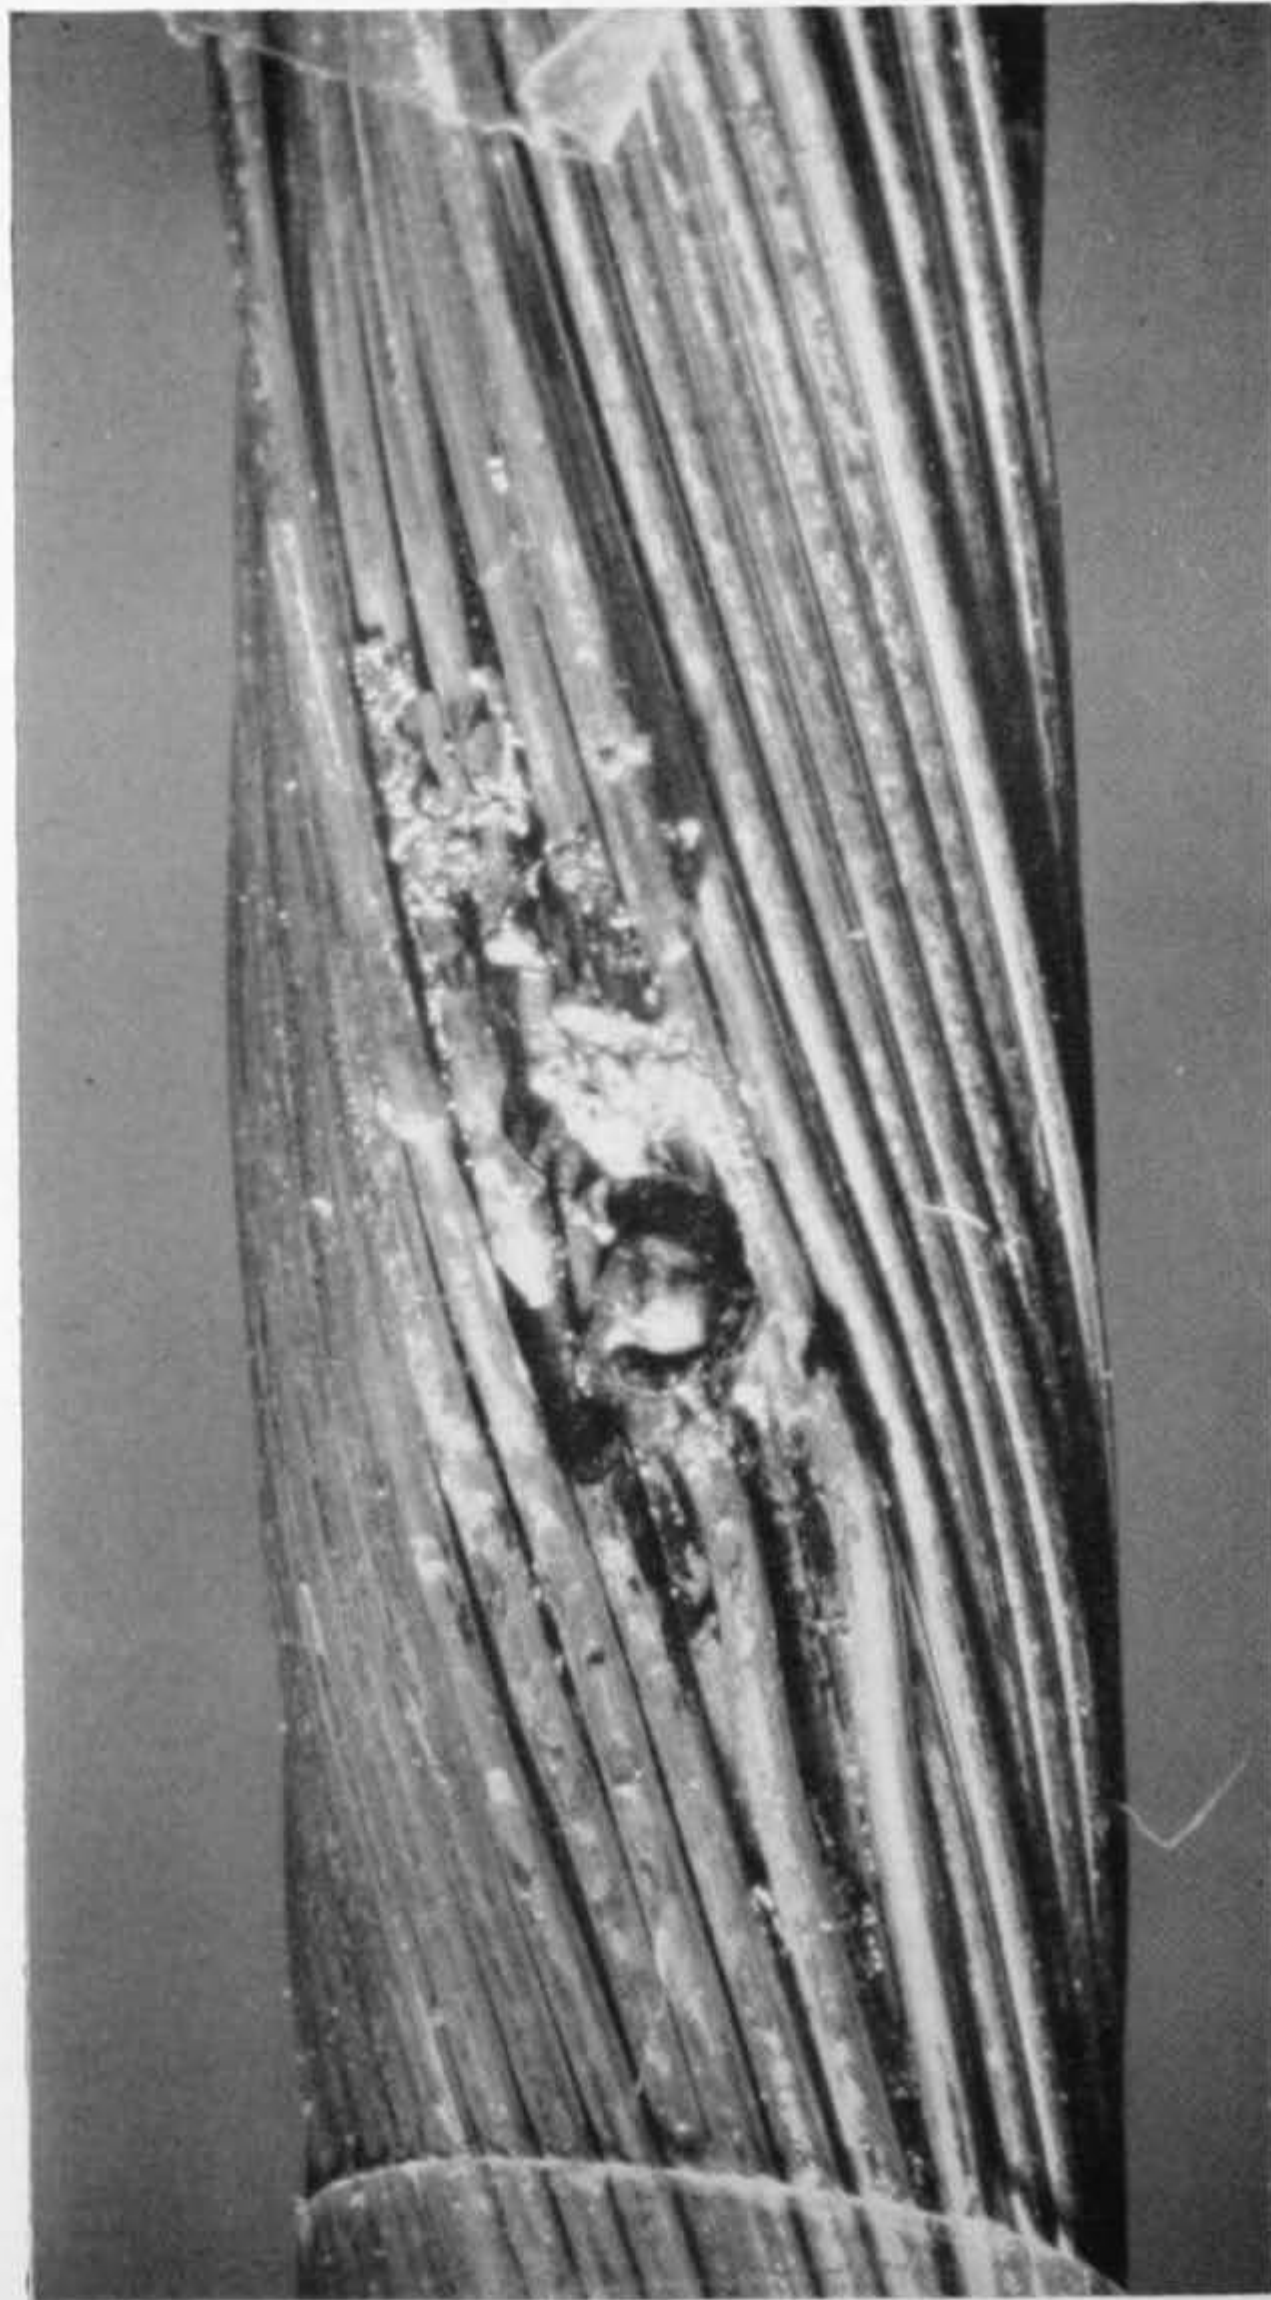
37. I conclude that the arcing occurred at the time of the explosion for there was no electrical defect except the damaged cable to account for the tripping of the earth leakage protective devices which had occurred simultaneously with the explosion. Such an arc could have firedamp. There was evidence that at the time of the explosion the cable was partly coiled up near the coal cutting machine, so that the damaged part was well within the area in which I conclude that the explosion had begun. The control wheel of the coal cutting machine had been found in the "check" position, that is to say, rotated sufficiently back from the "on" position to open the remote control contacts at the gate-end switch and make dead the power conductors of the trailing cable. This fact does not rule out the damaged cable as an igniting agent; had an arc occurred, the machine operator could easily and instinctively have moved the control wheel the small amount required to reach the "check" position.

38. I conclude that arcing from the damaged cable was the igniting agent.

PLATE IV.—View of damaged conductor removed from cable, showing fusion.
